TECHNICAL REPORT ARLCB-TR-77031

# EROSION IN 81MM MORTAR TUBES

V. Peter Greco

July 1977

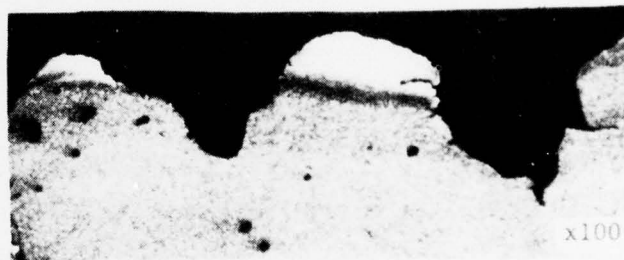
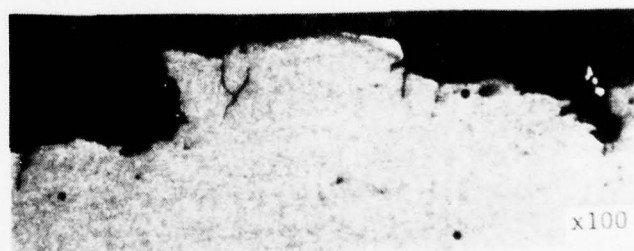
(A)  
SURFACE VIEW OF THE  
3 ERODED ANNULAR GROOVES  
(DARK BANDS)

(B)  
LONGITUDINAL CROSS SECTION  
SHOWING PROFILE OF THE  
FORWARD ERODED GROOVE

(C)  
MICROSCOPIC SURFACE VIEW  
OF FORWARD GROOVE SHOWING  
WHITE LAYER ON PEAKS

(D)  
MICROSCOPIC SURFACE VIEW  
OF THE FORWARD GROOVE  
SHOWING SEVERAL CRACKS

Figure 4. Eroded views of a condemned 81mm mortar tube after field firing of approximately 7500 rounds.

A severely eroded 81MM Mortar Tube (which was fired in the field) was metallographically studied in an attempt to determine the significant factors leading to the annular groove erosion which form the 3 rings. Figure 4a shows a sectional surface view of the 3 annular grooves. Figure 4b shows the longitudinal cross-sectional profile of the forward eroded groove. While visual examination of the eroded surface shows a severe pitted condition which appears to be caused by purely mechanical forces, microscopic cross-sectional examination (see Figures 4c and 4d) has revealed patches of the typical white layer (presumably due to thermal cycling) normally found in large caliber rifled gun tubes.

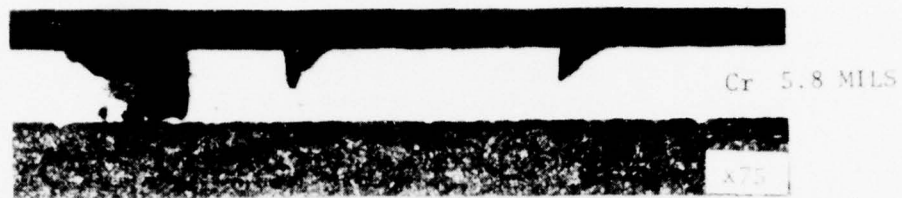
Figure 12. Cross section of chromium deposit on mortar steel with "V" notch sections removed, leading to early failure.

which were 2 mils or greater in thickness failed prematurely by excessive spalling and were withdrawn early during the 1500 rd test. Field tests also showed chromium coatings (2-5 mils thick) to perform poorly in a similar manner. An explanation for this behavior can be offered if we look at the wear plot from Finnie et al in Figure 5, which shows a brittle surface to result in greatest wear at a 90° angle of impingement. In reality, electrodeposited chromium can be classified as a brittle surface and therefore explains such a behavior. Figure 12 shows a cross-section of chromium on mortar steel with initial "V" notch segments of chromium progressively sheared away.
